Operation Rehabilitation Drive

Rapid flood impact assessment in
Kuttanad region

WORKING PAPER - 3

August 2018

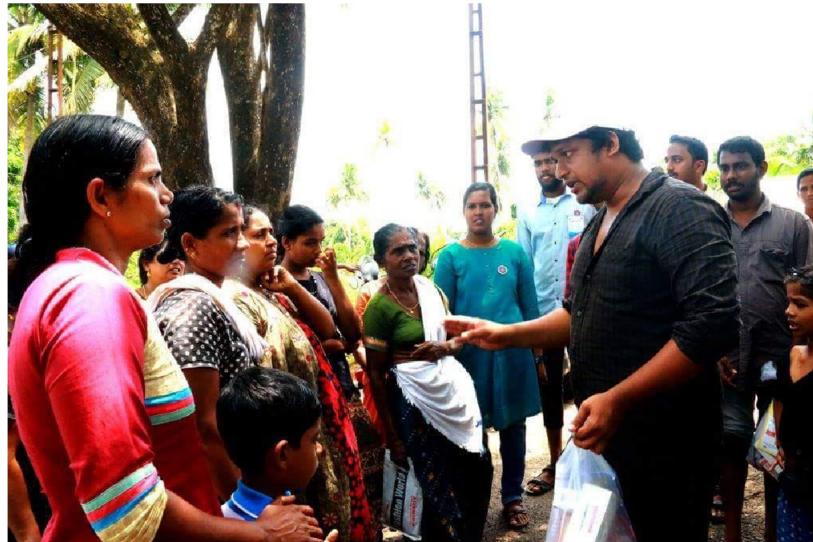
Figure 1 Socio-economic survey of households

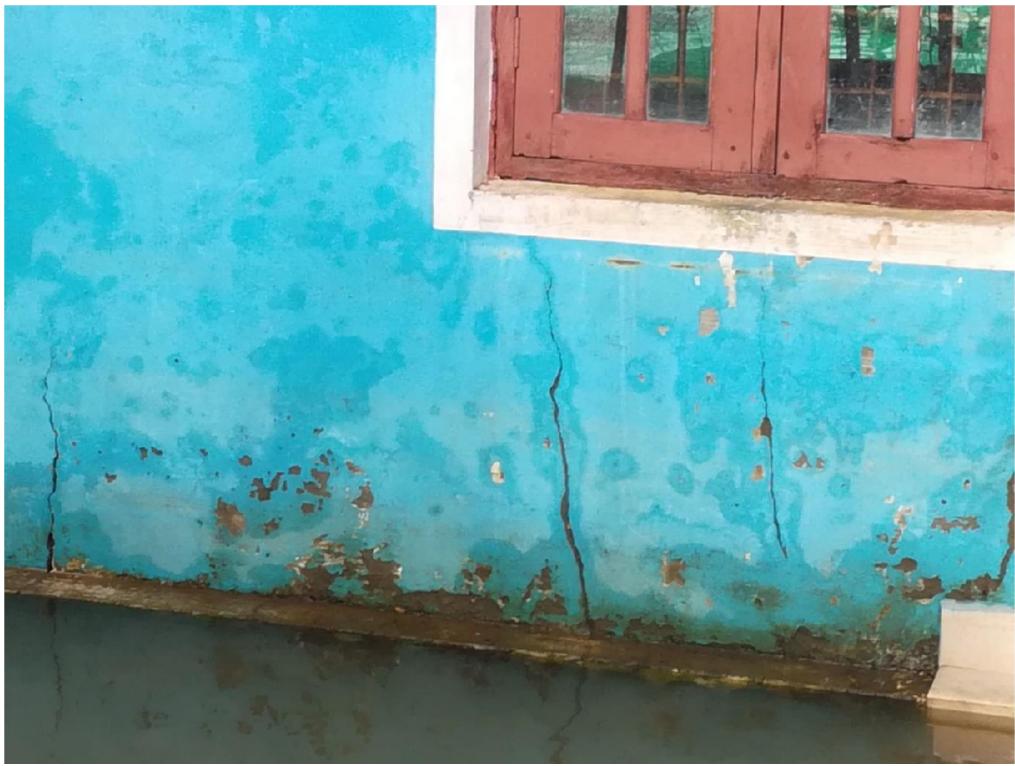
- 5.27% of houses are affected by the flood and require complete reconstruction or need major intervention.
- 65.67% of the houses analysed seem to require some intervention.
- 19.45% of the houses do not require any major renovation.

Figure 2 Structural Damage Analysis of Houses

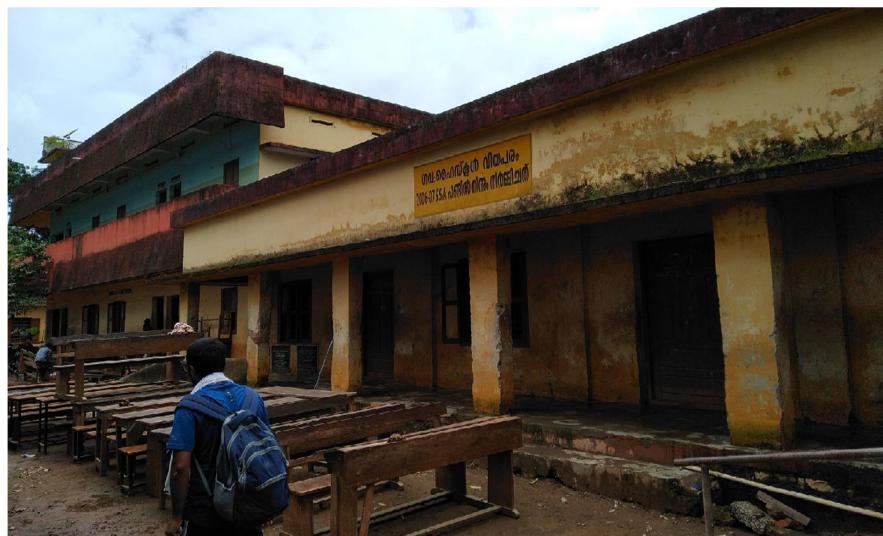
Upon analysis of the photos of the buildings (of a sample of 97 buildings), structural engineering experts found 9 institutions (10% of total) needed immediate attention. Drainage issues were found in few institutions and in about half of the institutions, damages were found but not flood related. But even in these buildings, the existing damages could have weakened the structure more during the flooding and hence they need to be addressed as well.

Figure 3 Structural damage analysis of public institutions

- About 10% of the public institution buildings surveyed need immediate action.
- There has been a considerable loss of infrastructure in the schools, anganwadis, primary health centres and government offices due to the floods. Along with the reconstruction work on the buildings, focus should also be to repair and buy new infrastructure for these public institutions.
